NATIONAL PROGRAM FOR INSPECTION OF NON-FEDERAL DAMS
PALMER BROOK DAM MA 0 (U) CORPS OF ENGINEERS WALTHAM
MA NEW ENGLAND DIV MAR 81

4. TITLE (and Subtitle) Palmer Brook Dam NATIONAL PROGRAM FOR INSPECTION OF NON-FEDERAL DAMS		5. TYPE OF REPORT & PERIOD COVERED INSPECTION REPORT
7. AUTHOR(s) U.S. ARMY CORPS OF ENGINEERS NEW ENGLAND DIVISION		6. PERFORMING ORG. REPORT NUMBER

Palmer Brook Dam

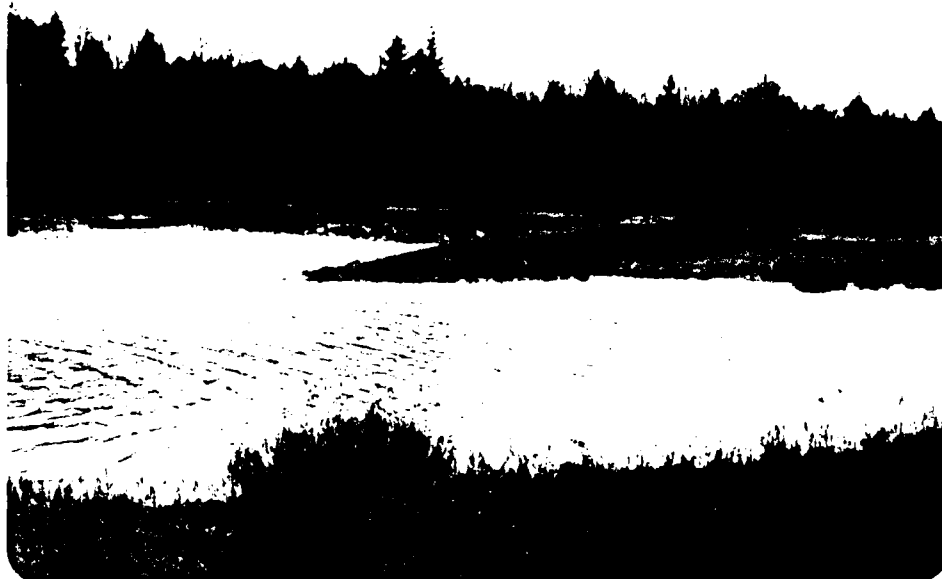
Photo No. 1

View of the upstream face of the dam. The grass-lined emergency spillway is on the right.

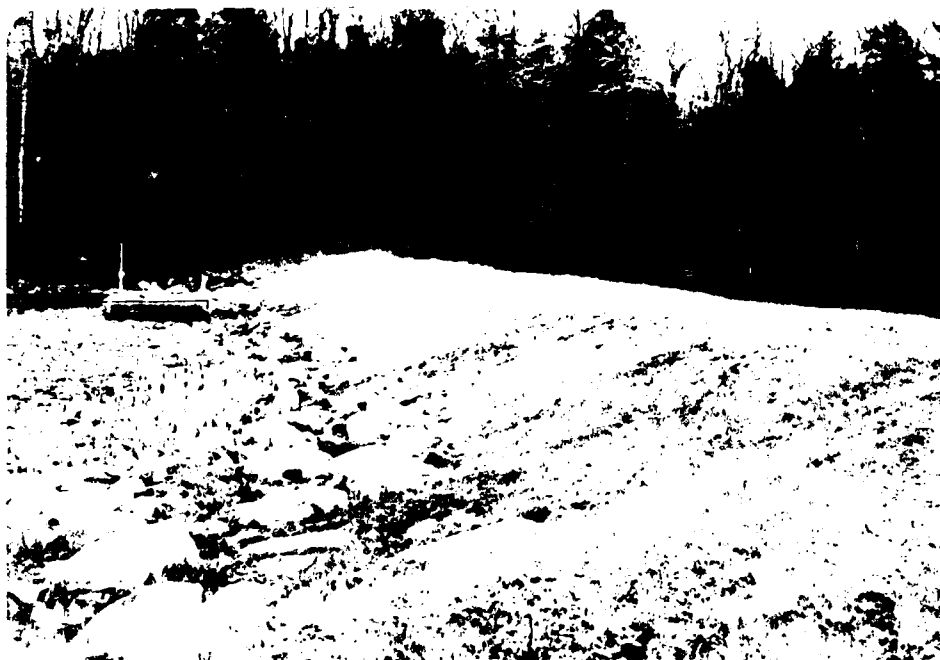
Photo No. 2

a. Dam. The upstream slope (down to the top of the riprap), the crest, and the downstream slope of the embankment are covered with grass which has been mowed. The appearance of the embankment indicates that it is well maintained and in good condition (Photo Nos. 1, 2, and 4). There is a boulder-riprap on the upstream slope from approximately the elevation of the top of the drop-inlet structure to some elevation (which could not be determined from the visual inspection) below the pond level (Photo No. 2).

Both abutments of the dam consist of soil, and the contacts between the embankment and the abutments are in good condition (Photo Nos. 2 and 5).

View of the upstream slope looking toward the left abutment. The service spillway intake is in the left center of the photo. Note mowed grass and boulder riprap.

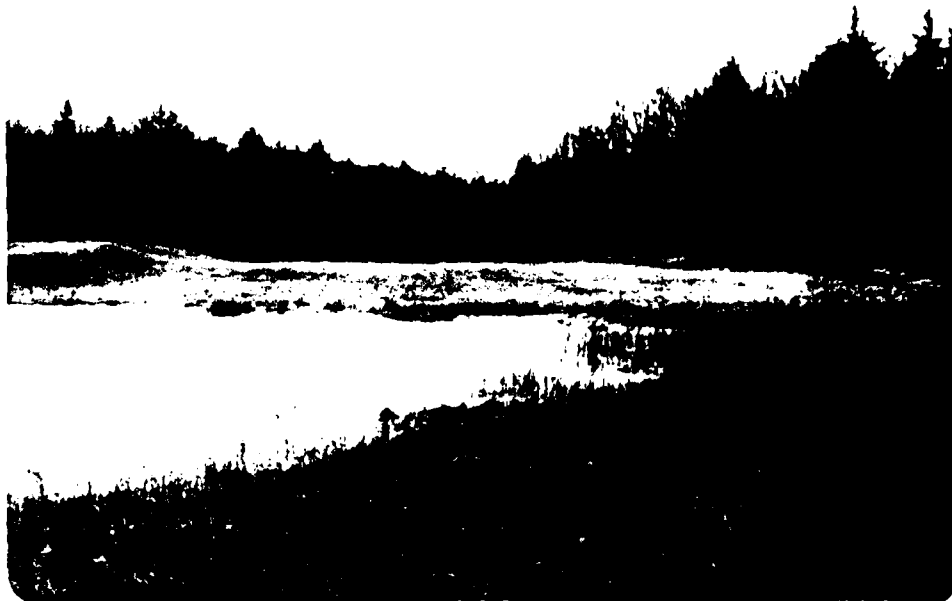
Photo No. 5

View of grass-covered emergency spillway, looking downstream
from right bank of approach channel.

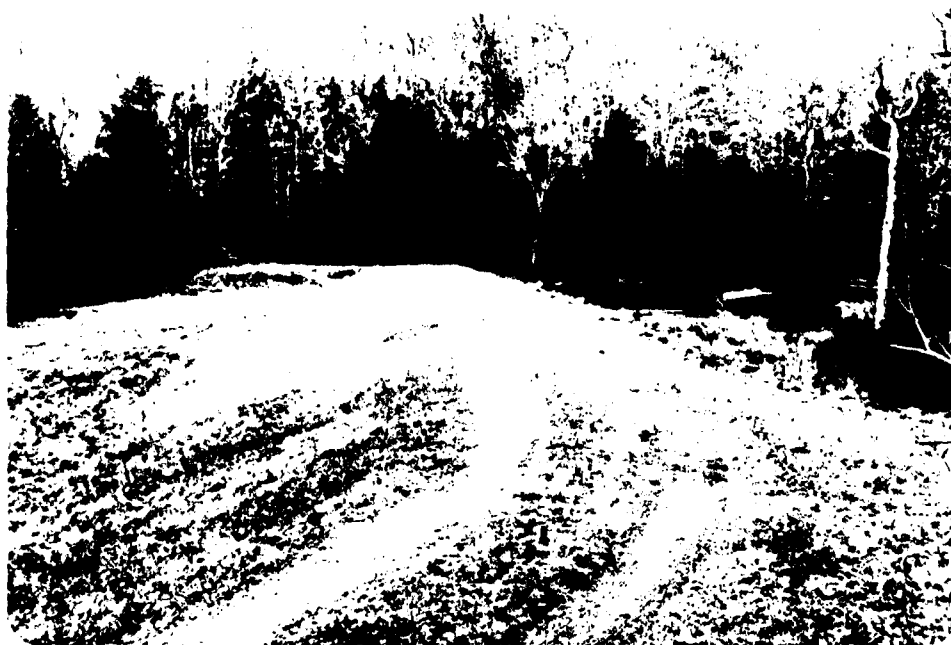
Photo No. 6

3.2 Evaluation. On the basis of the visual inspection, the dam is judged to be in good condition and appears to be well-maintained. A few trees growing at the downstream end of the emergency spillway could retain debris and result in a reduction of the emergency spillway capacity when it discharges water. The wheel tracks on the crest of the dike (Photo No. 6) could be a focus for erosion if the dike were overtopped.

View of dike, looking toward right abutment.
Note mowed grass and wheel tracks.

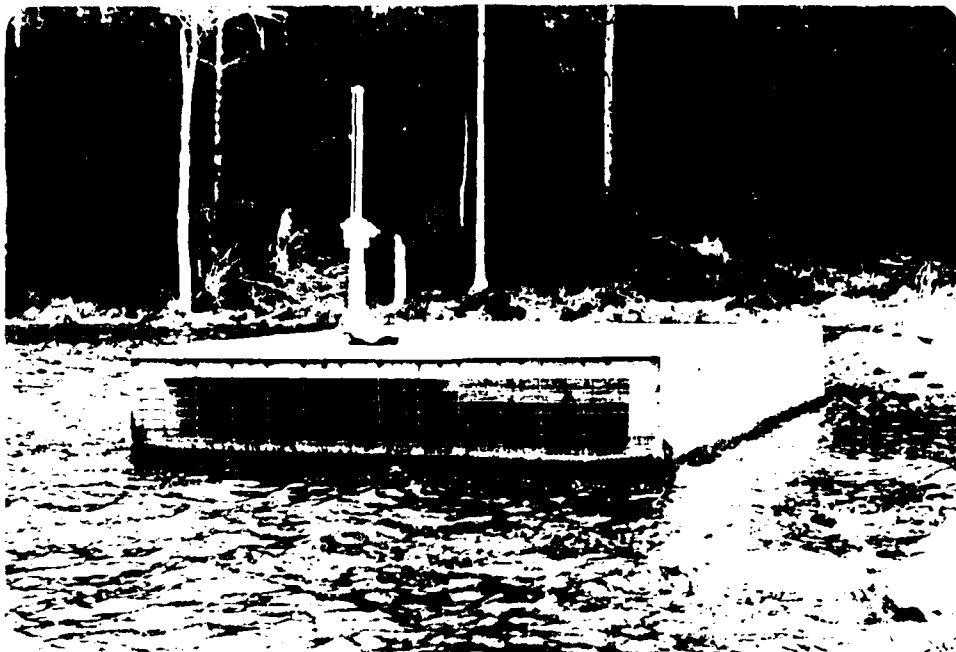
Photo No. 3

b. Operating Facilities. The only mechanically operable facility is the 36-inch diameter slide gate. This facility has reportedly been serviced by representatives of the manufacturer, the Rodney Hunt Co., and appears to be in good condition.

View of the service spillway intake. Note trash screens and slide gate operating mechanism.

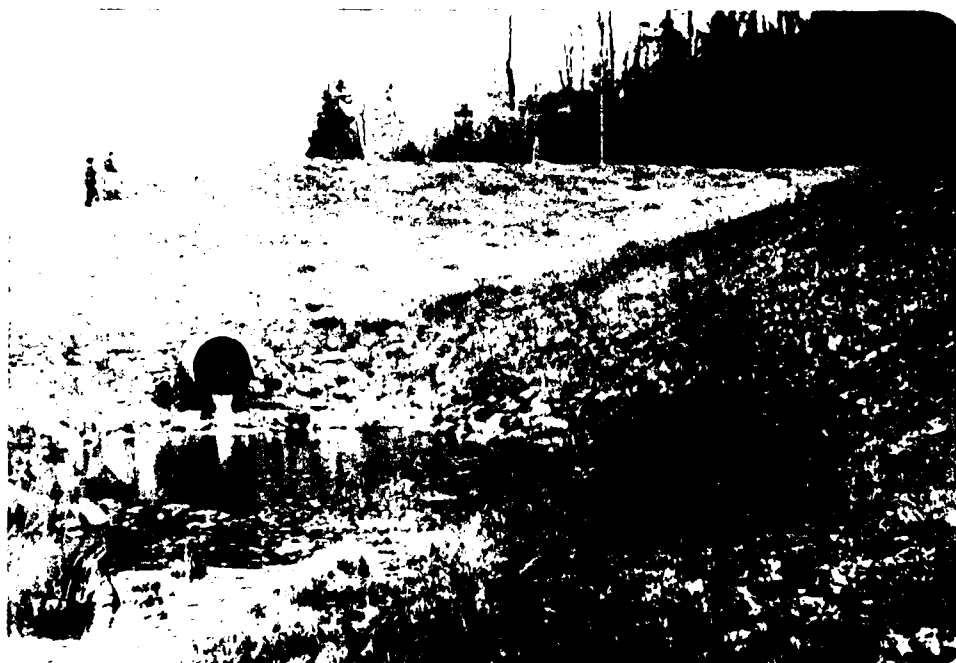
Photo No. 4

No evidence of seepage on the downstream slope or in the downstream toe area was observed.

View of downstream slope, principal spillway outlet conduit, and stilling pool and exit channel.
